# EV & PHEV 3-Phase Breakout Test Lead W3PhBTL

## Electric and Hybrid Vehicle 3-Phase Testing

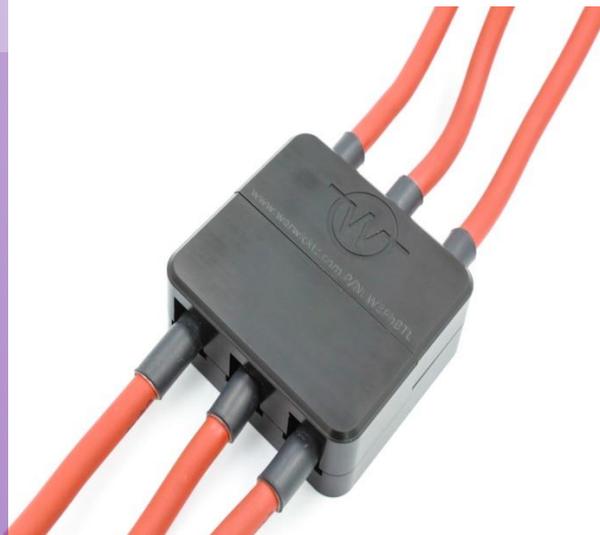
- Conduct fast and safe testing of electric motor and generator stator windings
- Connect in-line as a breakout test lead.
- No need to damage 3-Phase cable screening to gain access to the wiring.
- Safely measure current of each phase with a 3-Phase inductive tester.

The W3PhBTL is designed to simplify 3-Phase stator motor and generator testing by creating an in-line breakout of the 3-Phase wiring. By placing it in the circuit there is no requirement to manipulate and pull apart the cable shielding braiding to gain adequate access to the wiring.

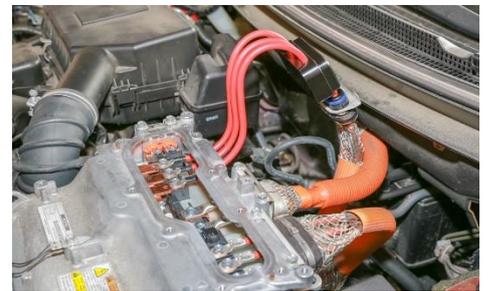
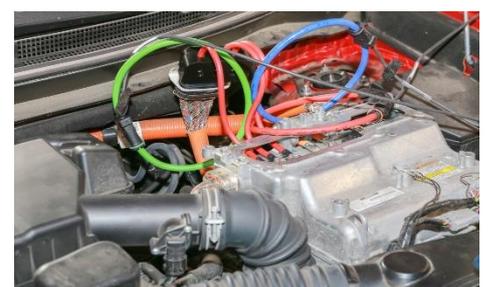
The swift process of disconnecting and connecting the 3-Phase cable with the W3PhBTL will save technicians approximately 1hr of work by removing access difficulties and the requirement to make good any damage to the cable shielding.
